Manhole Inspection Summary

Manhole # S31SS_048MH

Location Address: **2824 FOX ST**

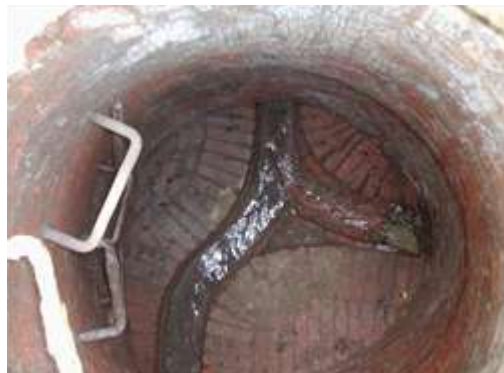
Top View

Corroded steps. Channel debris.

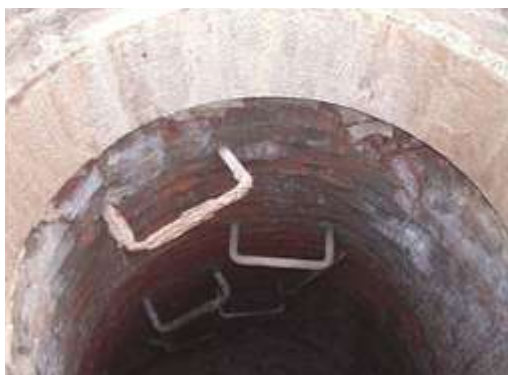
Defect

Frame leaks. Adjustment deterioration and infiltration. Corbel and Barrel infiltration - other side.

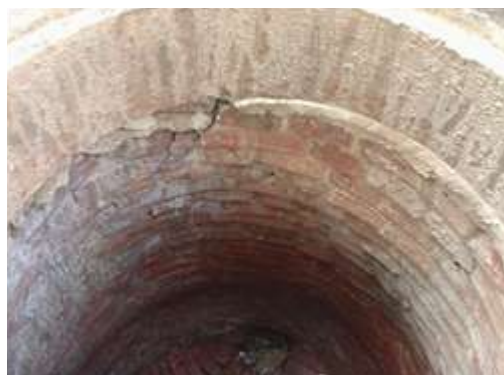
Defect

Frame leaks. Adjustment deterioration and infiltration. Corbel and Barrel infiltration.

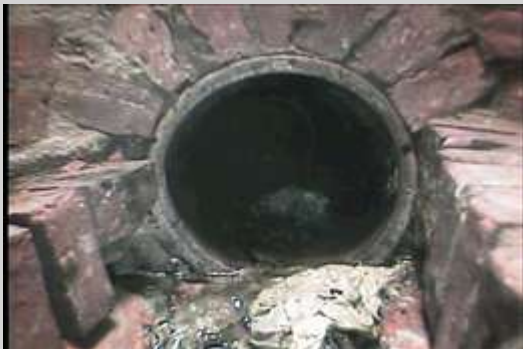
8 in. Circular Gravity Sewer Pipe In @ 3 O'Clock

Channel deterioration.

Deposits: ☐ None ☒ **Mud** ☐ Sludge ☒ **Debris** ☐ Grease

Infiltration: **Evidence** Pipe Seal Cond: **Unknown**
